**PHASE II ENVIRONMENTAL SITE ASSESSMENT
THE BELL BUILDING
1605 CENTRAL AVENUE
CHEYENNE, LARAMIE COUNTY, WYOMING
REVISION 1**

Date Prepared	February 2019
TDD No.	0003/1810-20
Document Control No.	W0652.1B.01846
Contract No.	EP-S8-13-01
U.S. EPA Work Assignment Manager	Ted Lanzano

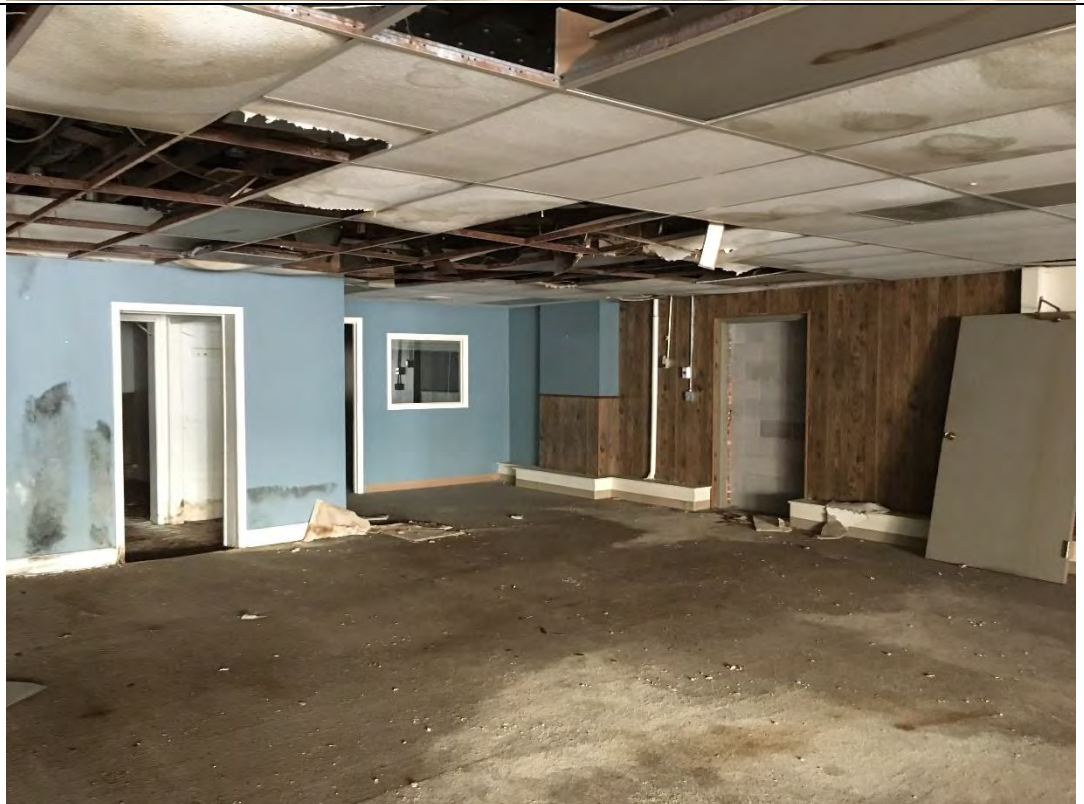
Photo No. 3	Date: 08/24/2017
Photo Coordinates	
Lat	41.133553
Long	-104.8142
Direction Photo Taken: 194.029069767442	
Description: Mold observed on the main level of the building.
